The Design
and
Methods of Construction
of
Welded Steel Merchant Vessels

FINAL REPORT OF A BOARD OF INVESTIGATION

To Inquire Into
THE DESIGN
AND METHODS OF CONSTRUCTION
OF WELDED STEEL MERCHANT
VESSELS

15 JULY 1946

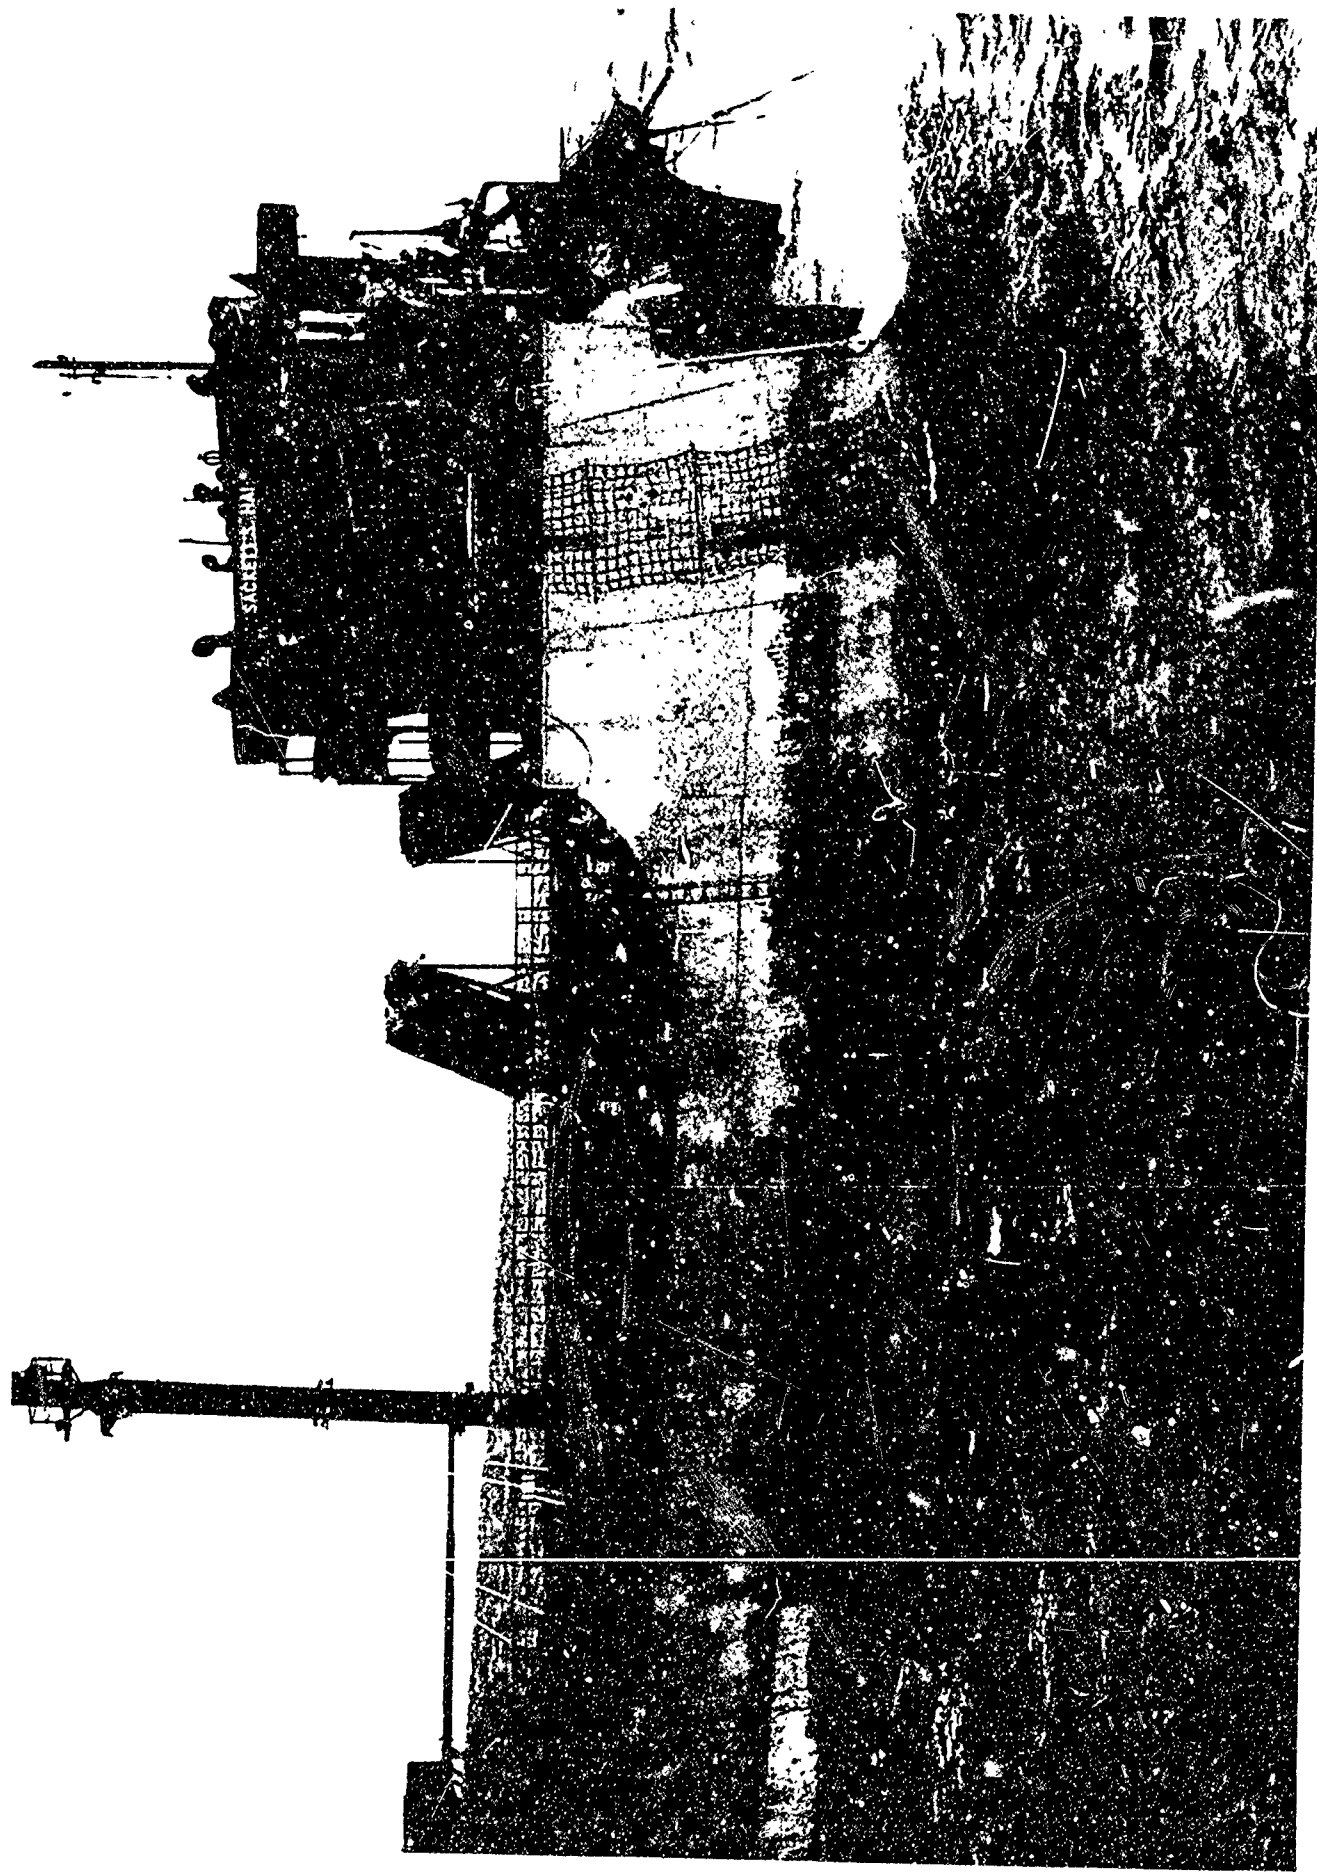
FIGURE 9.—Forward portion of S. S. Sackett Harbor.

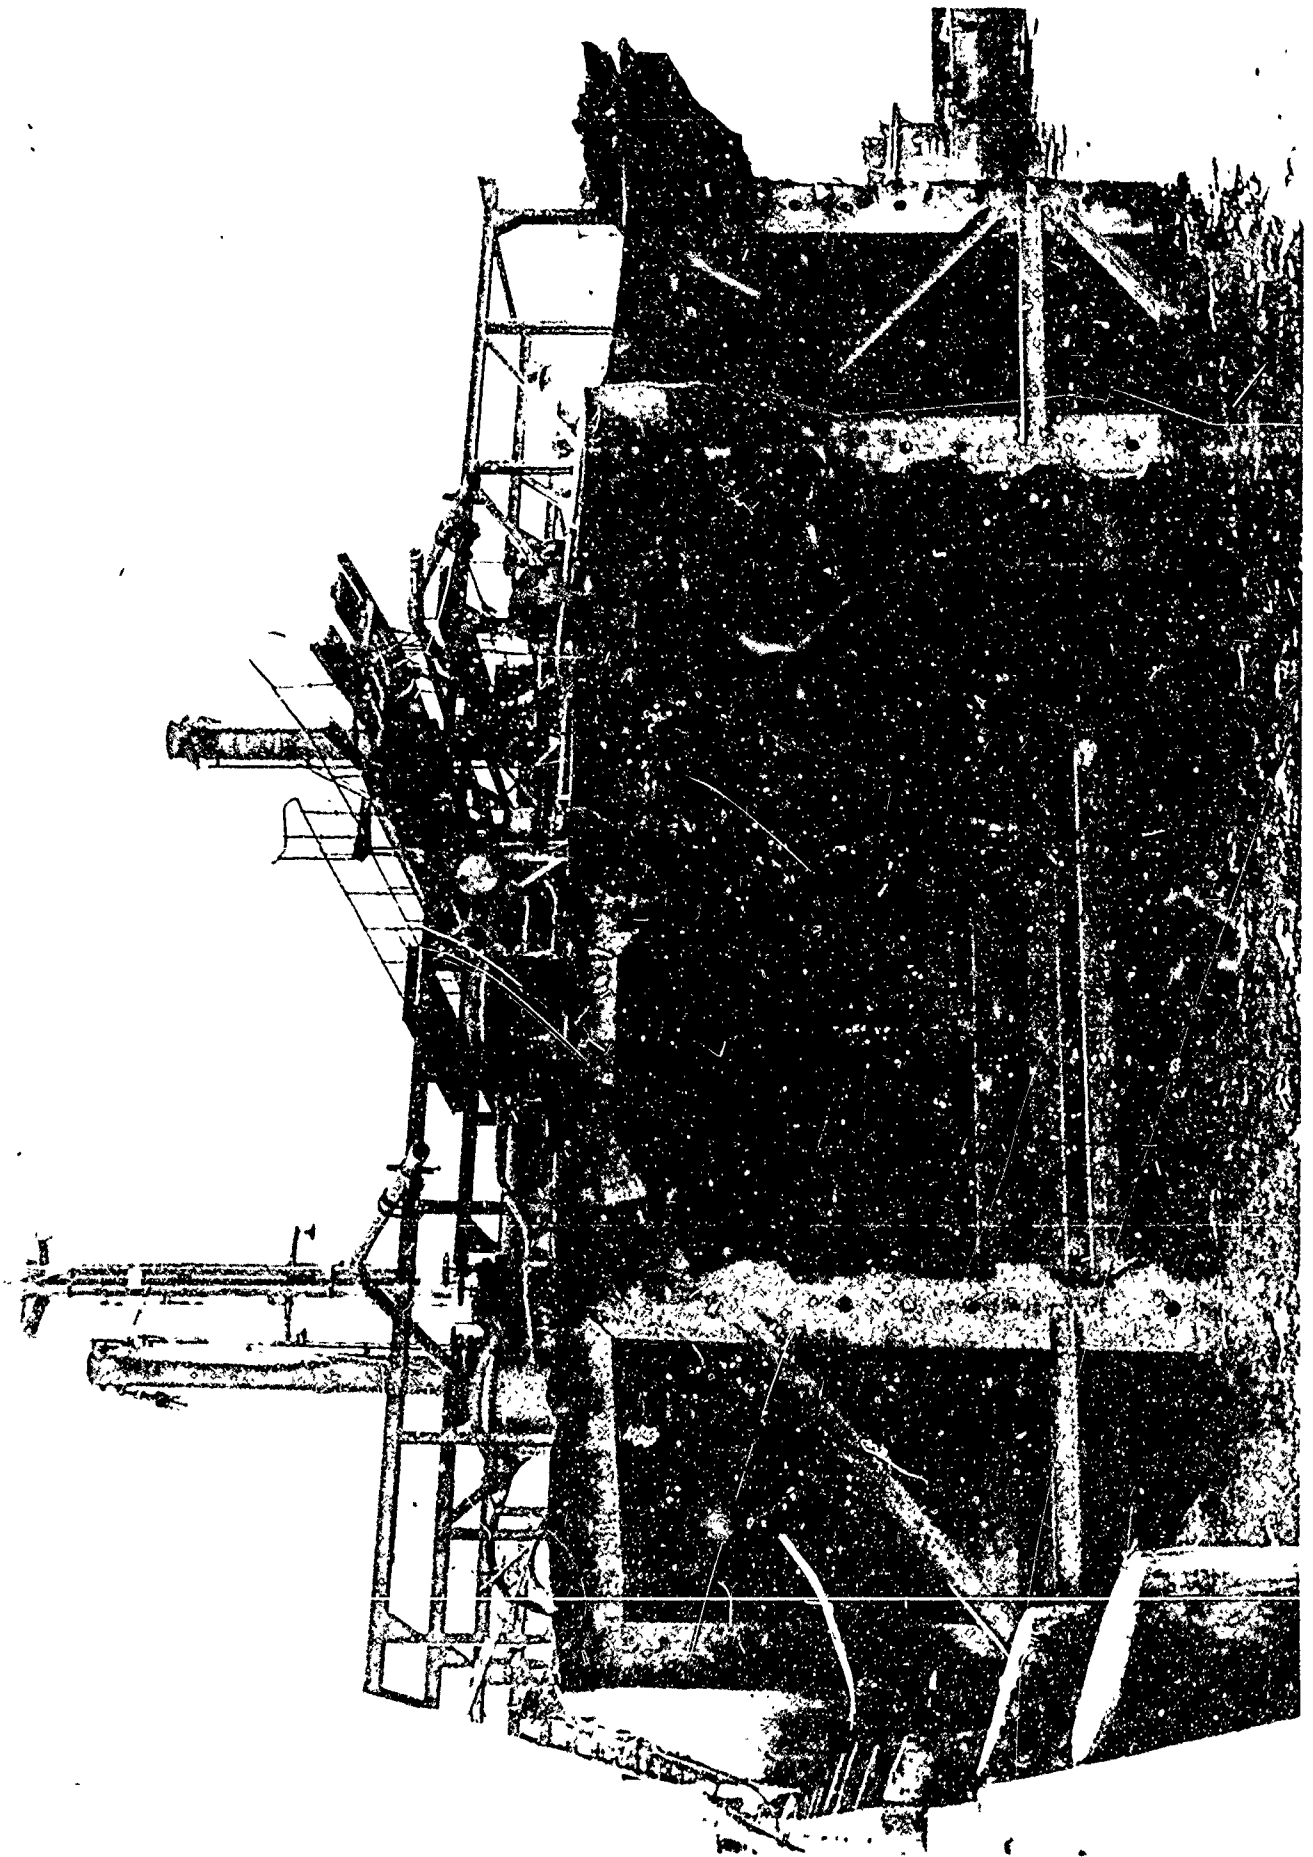
Stern section awaiting tow; bow section sunk by gunfire.	
SIGNED (Name and Title)	DISTRICT

FIGURE 10.—Stern portion of *U.S.S. Sackett's Harbor*.

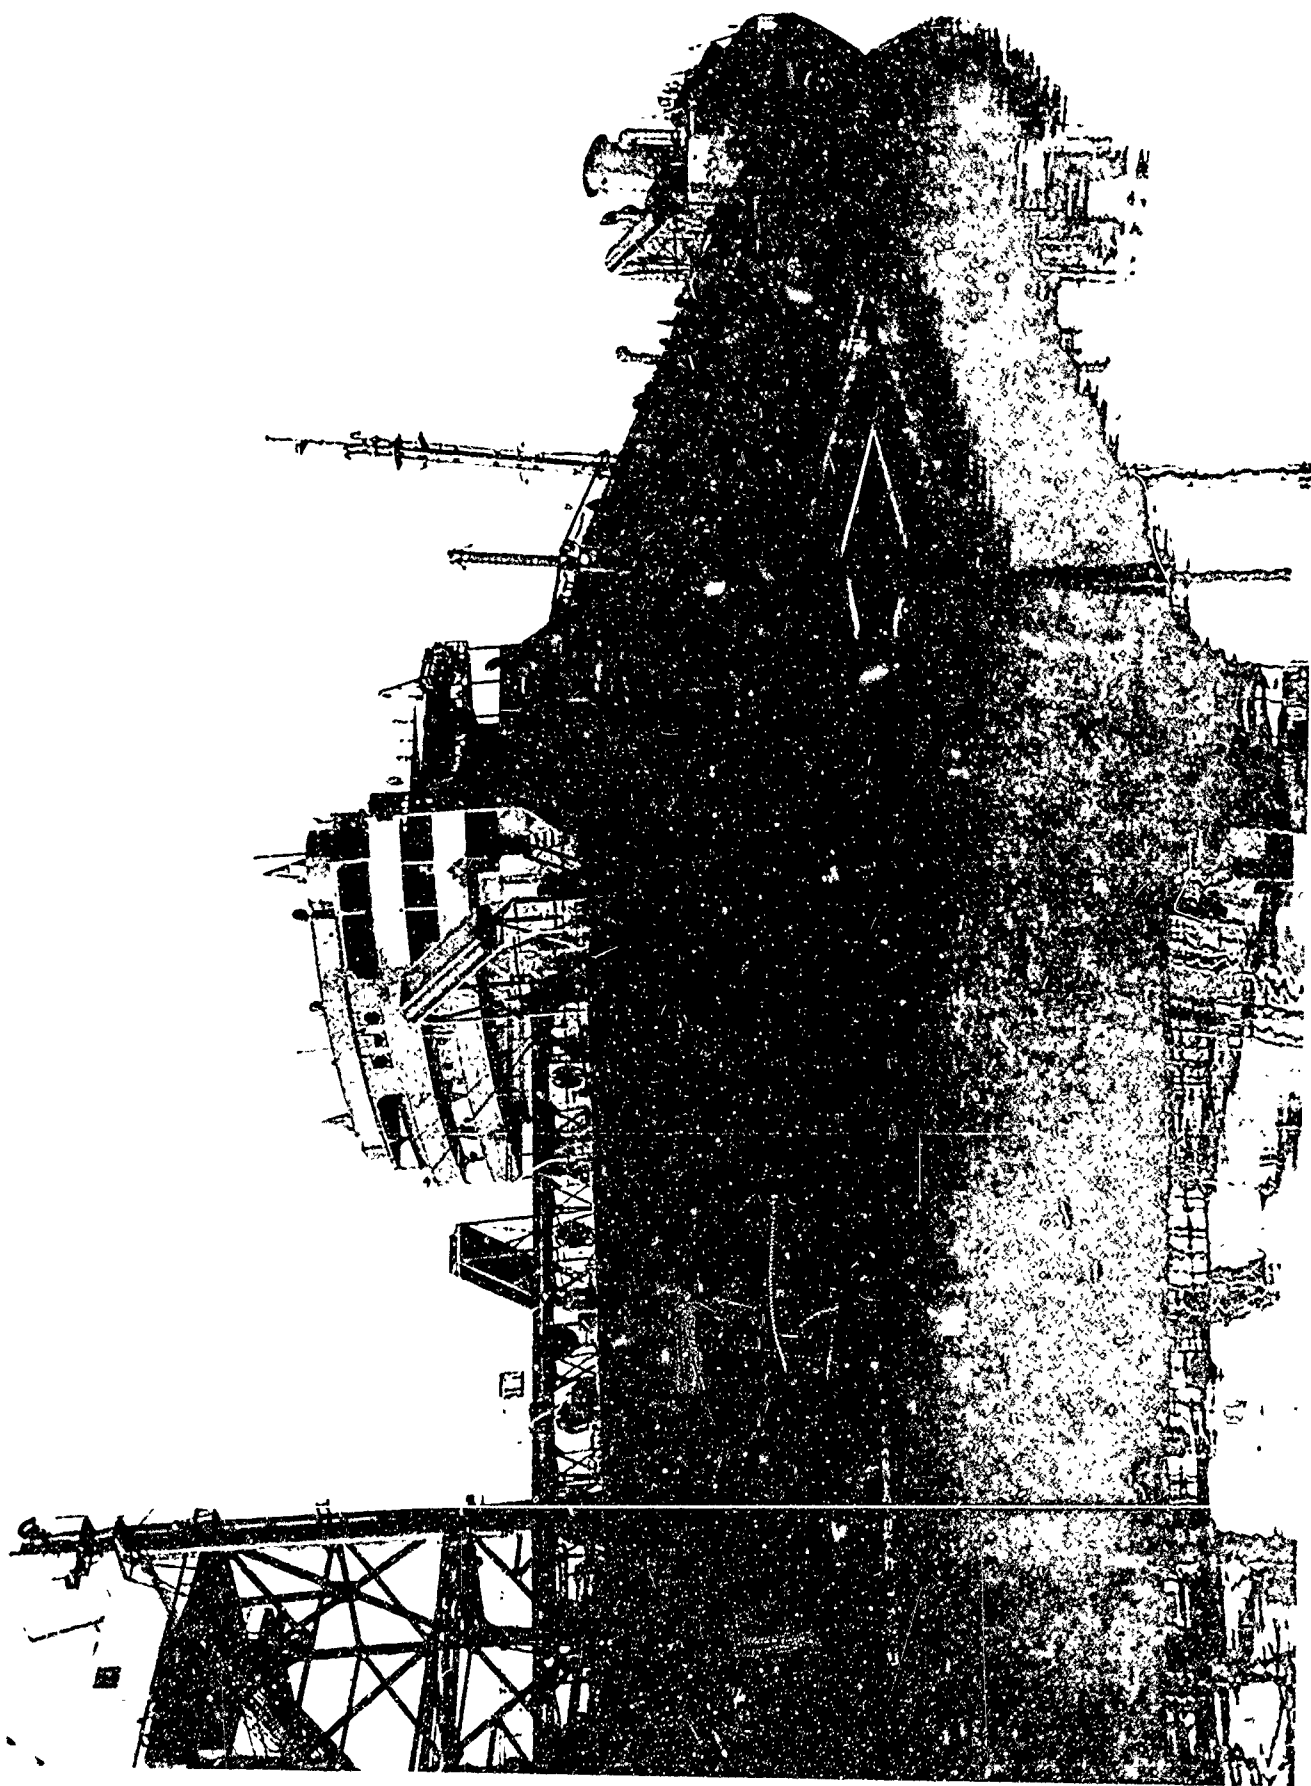
FIGURE 11.—View of S. S. Schenectady after splitting in two at her outfitting dock.

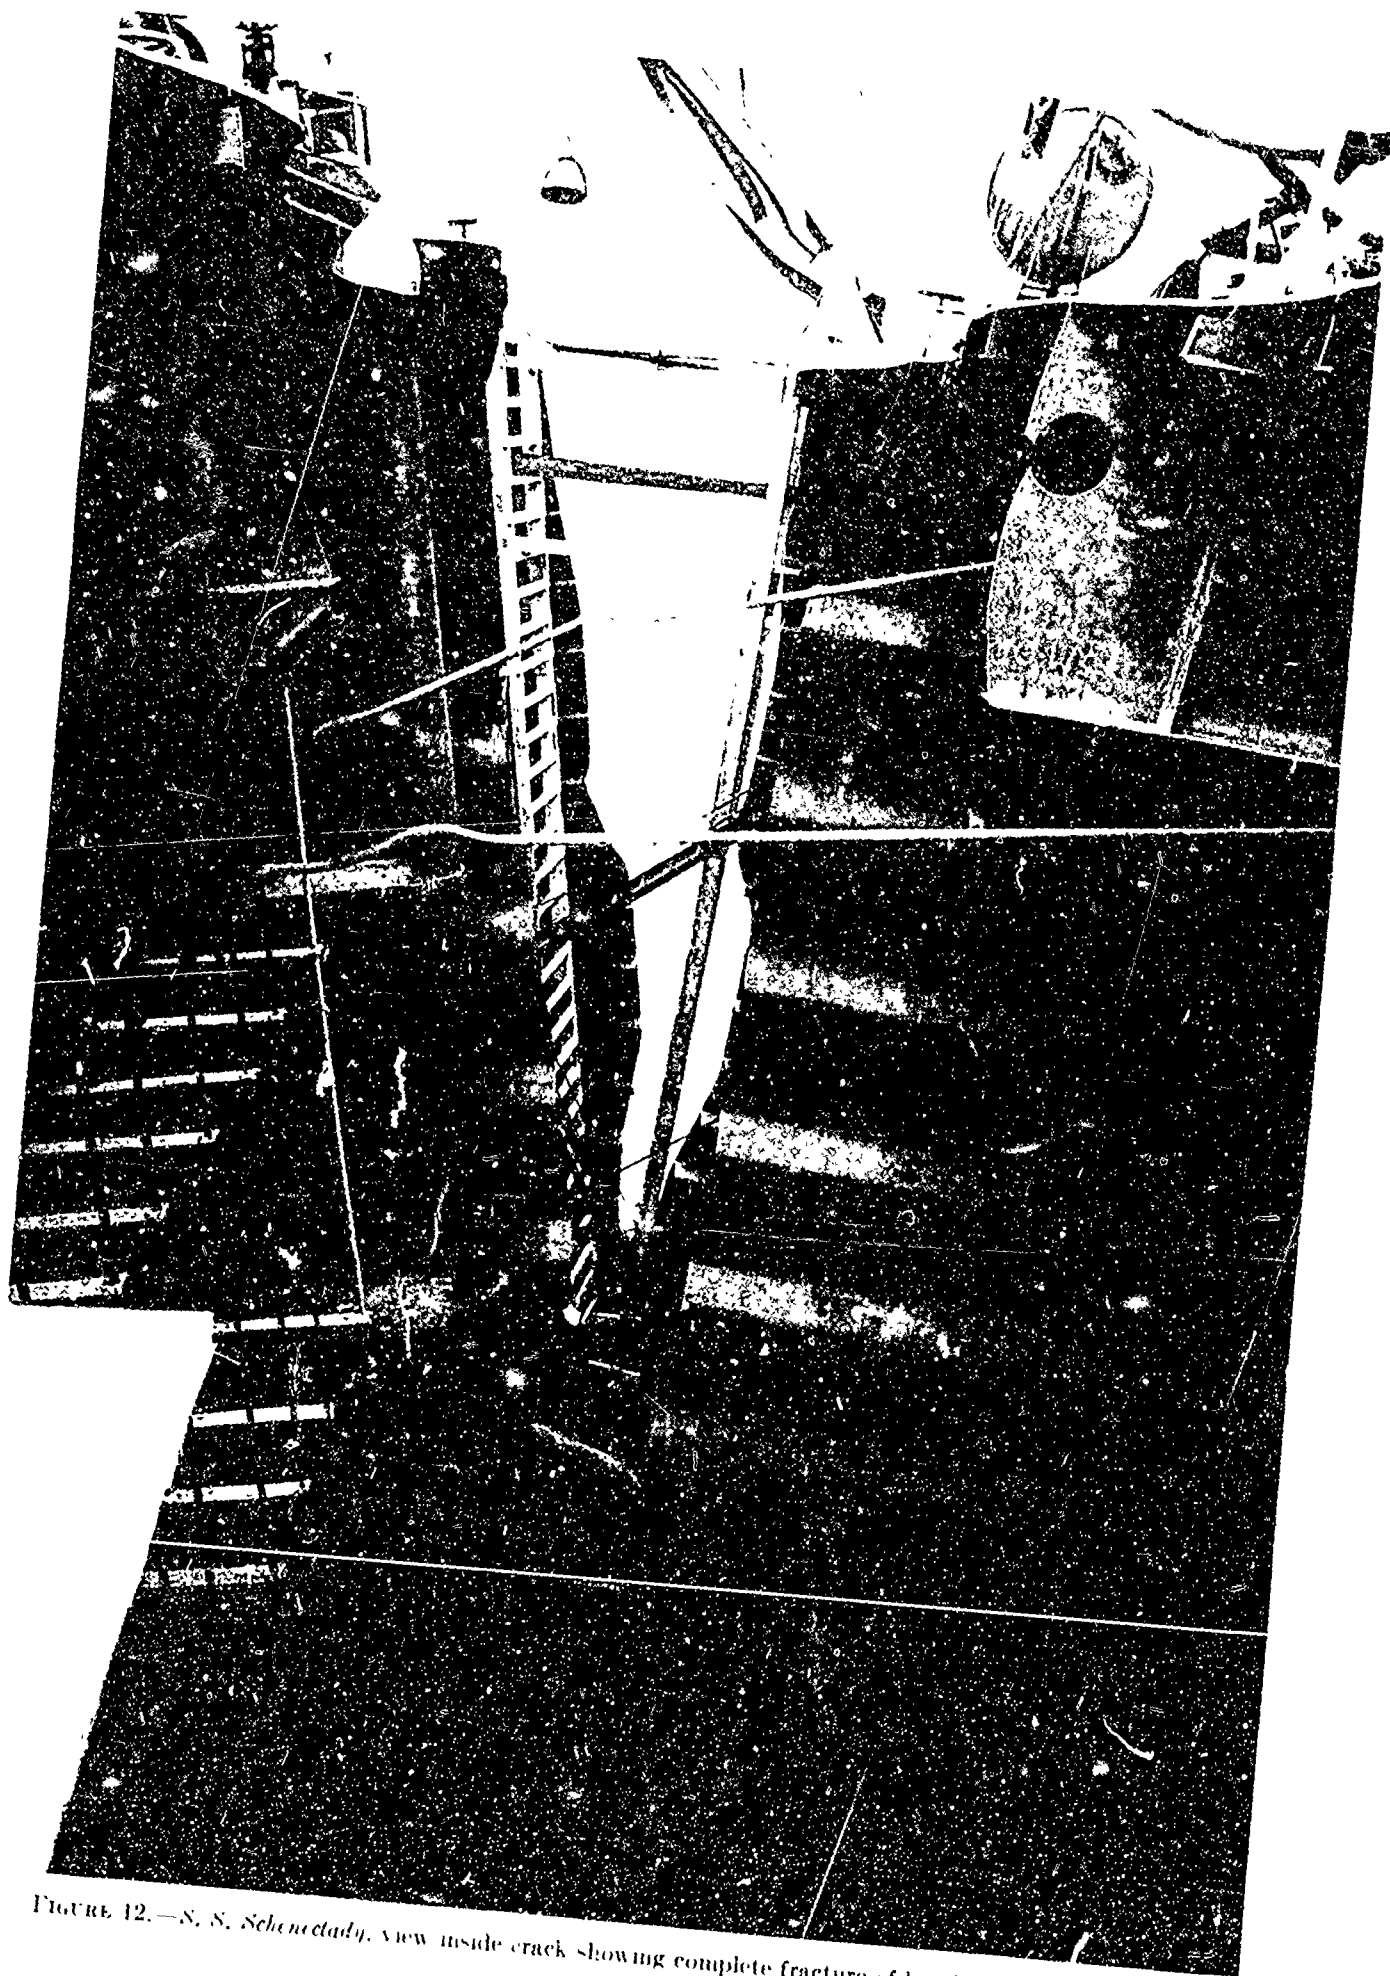
FIGURE 12.—S. S. *Schenckady*, view inside crack showing complete fracture of longitudinal bulkheads.

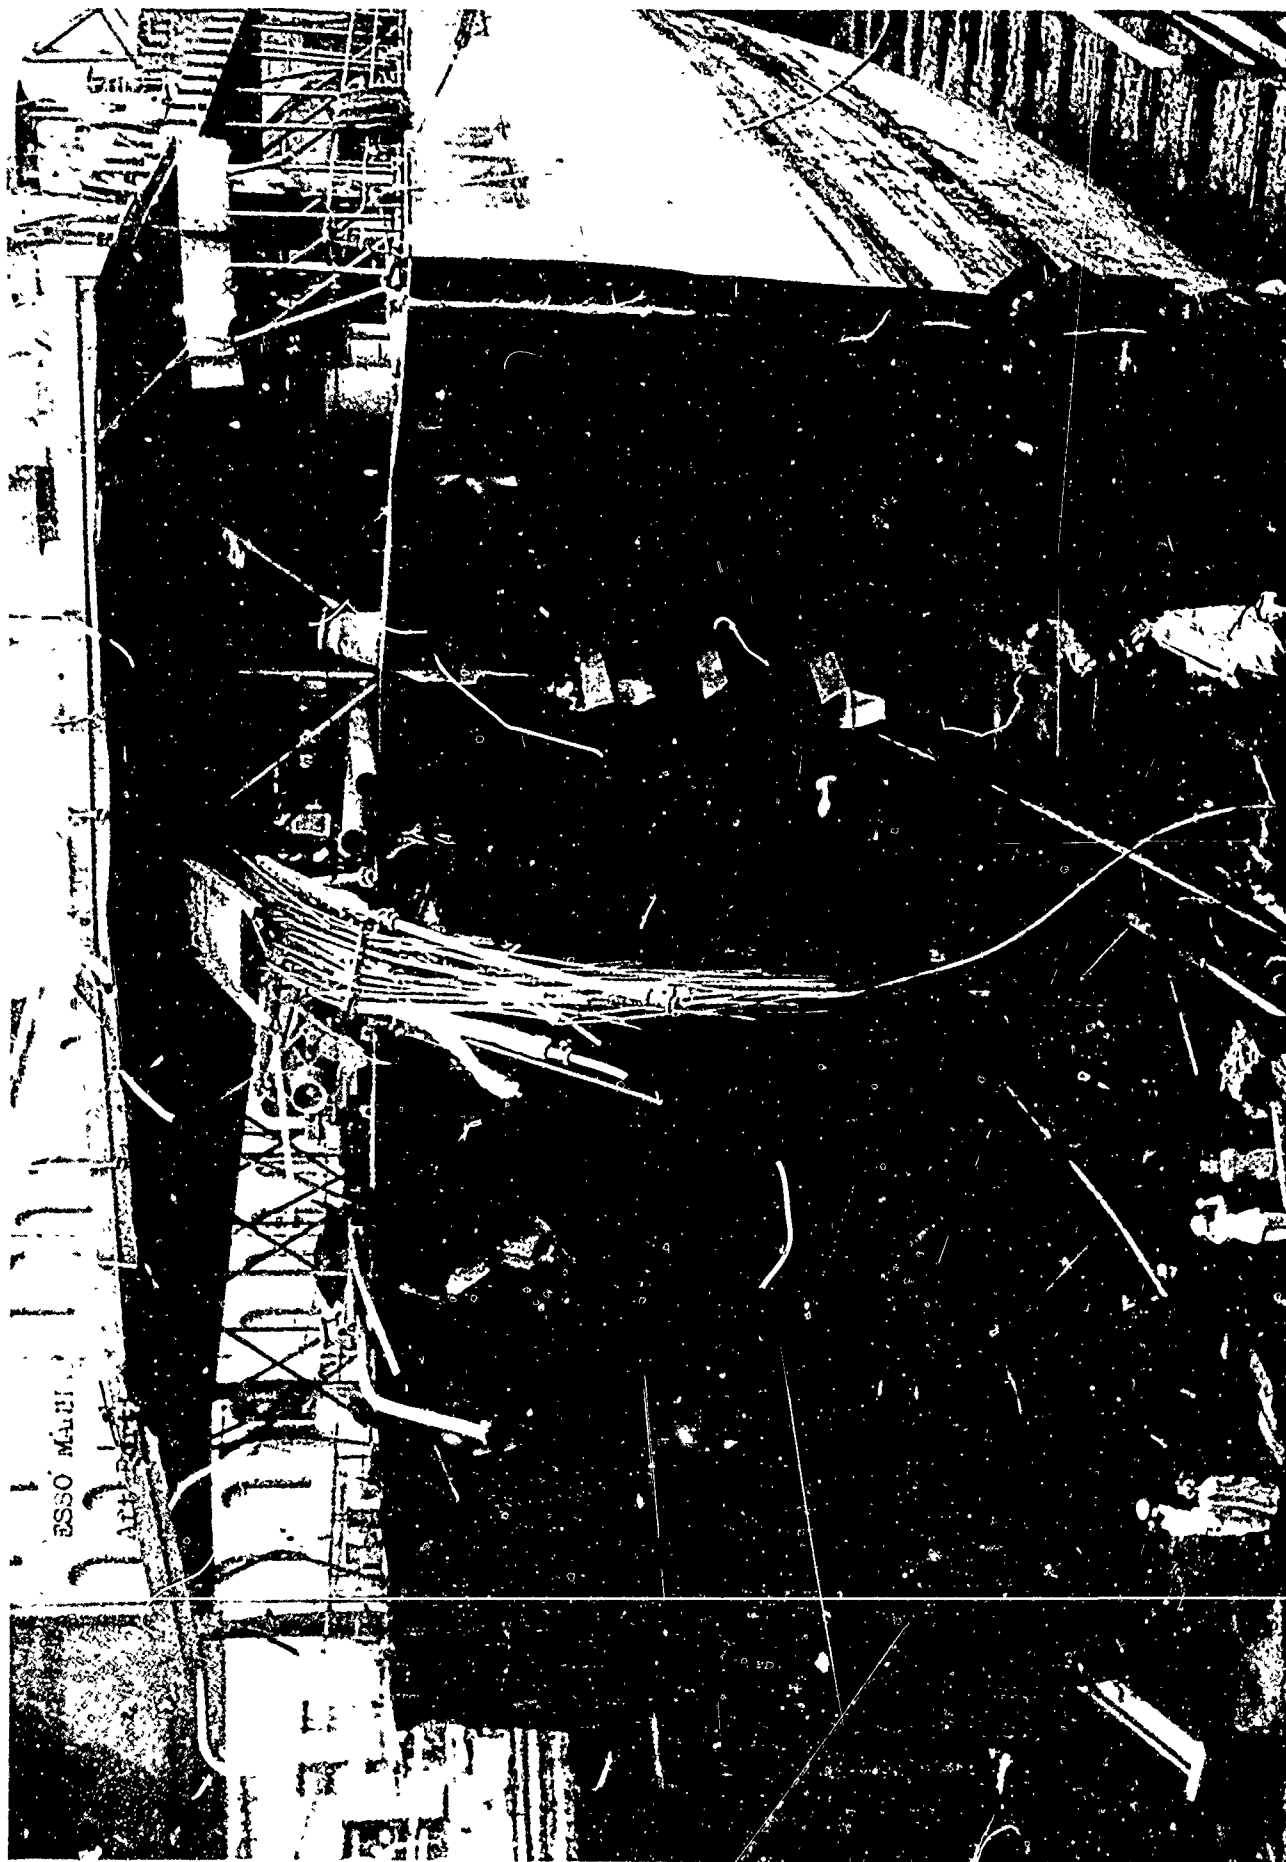
Figure 17.—Aft portion S. S. Esso Manhattan.

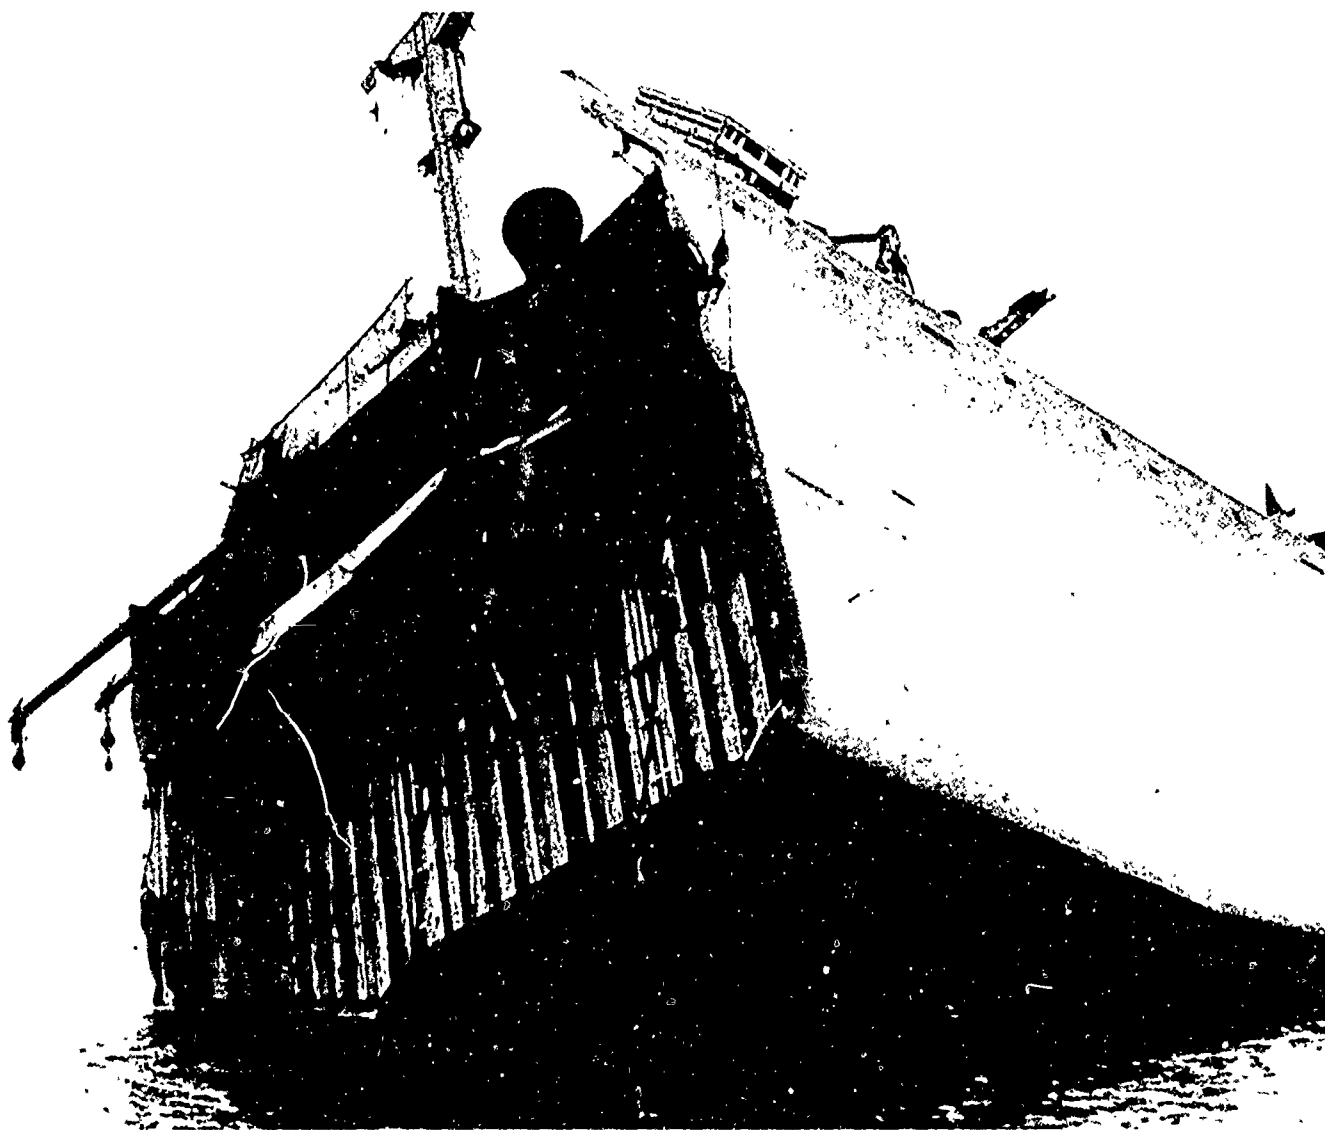
FIGURE 18.—Forward portion of *S. S. Valeri Chkalov*.

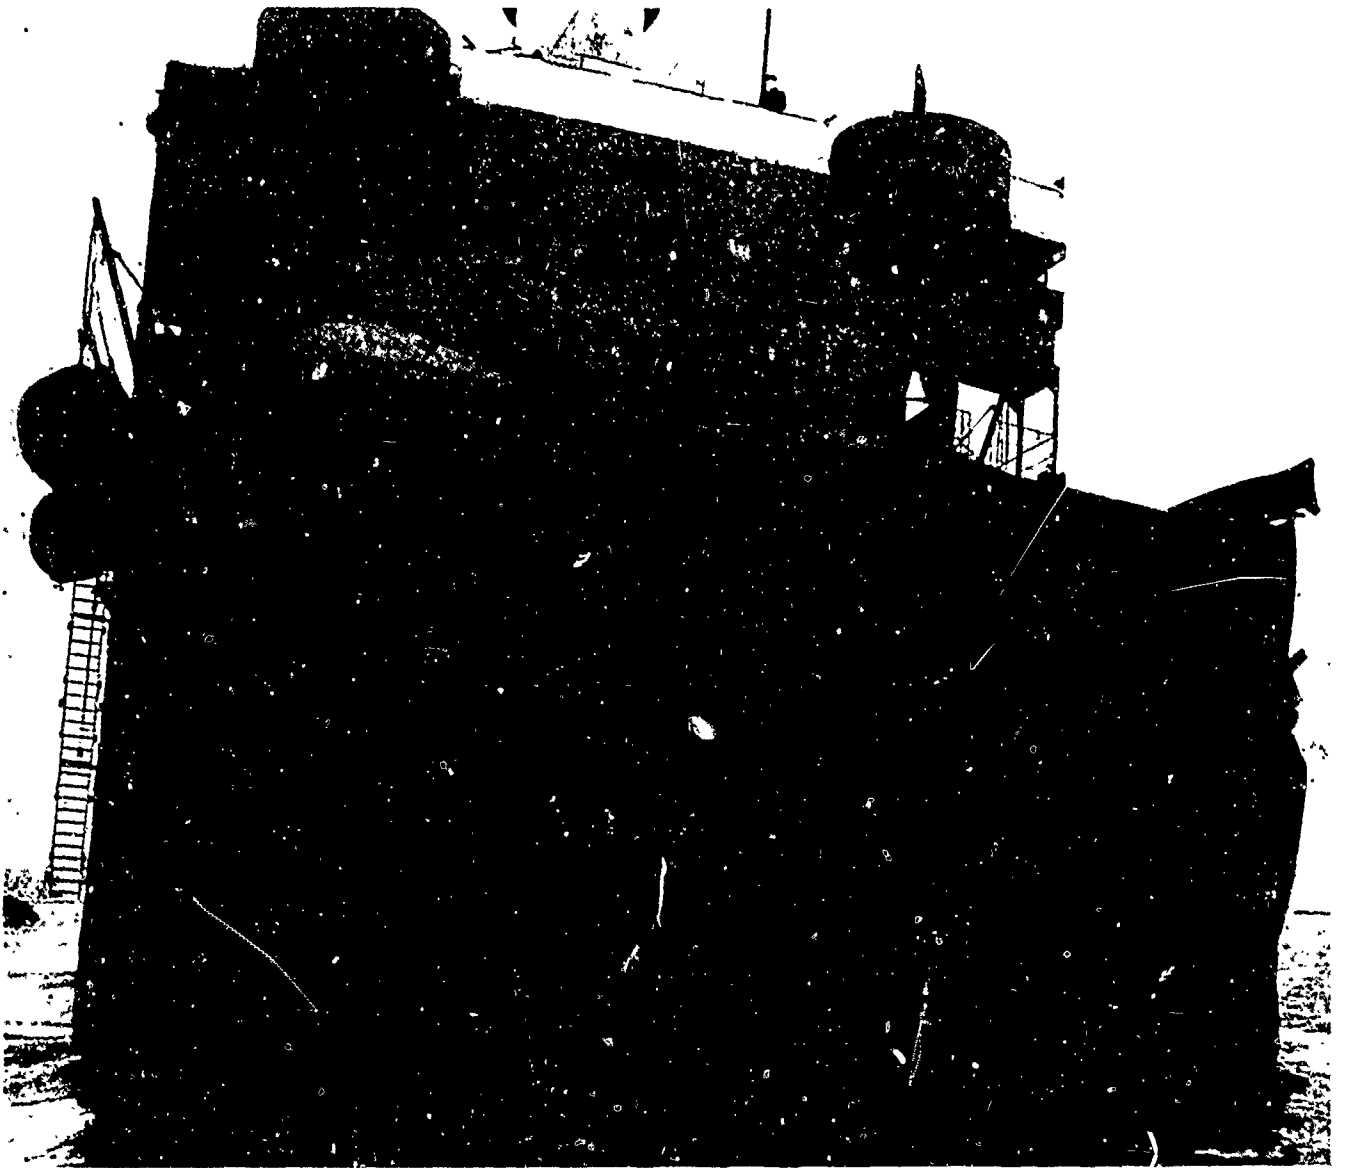
FIGURE 19.—Stern portion of *S. S. Valeri Chkalov*.

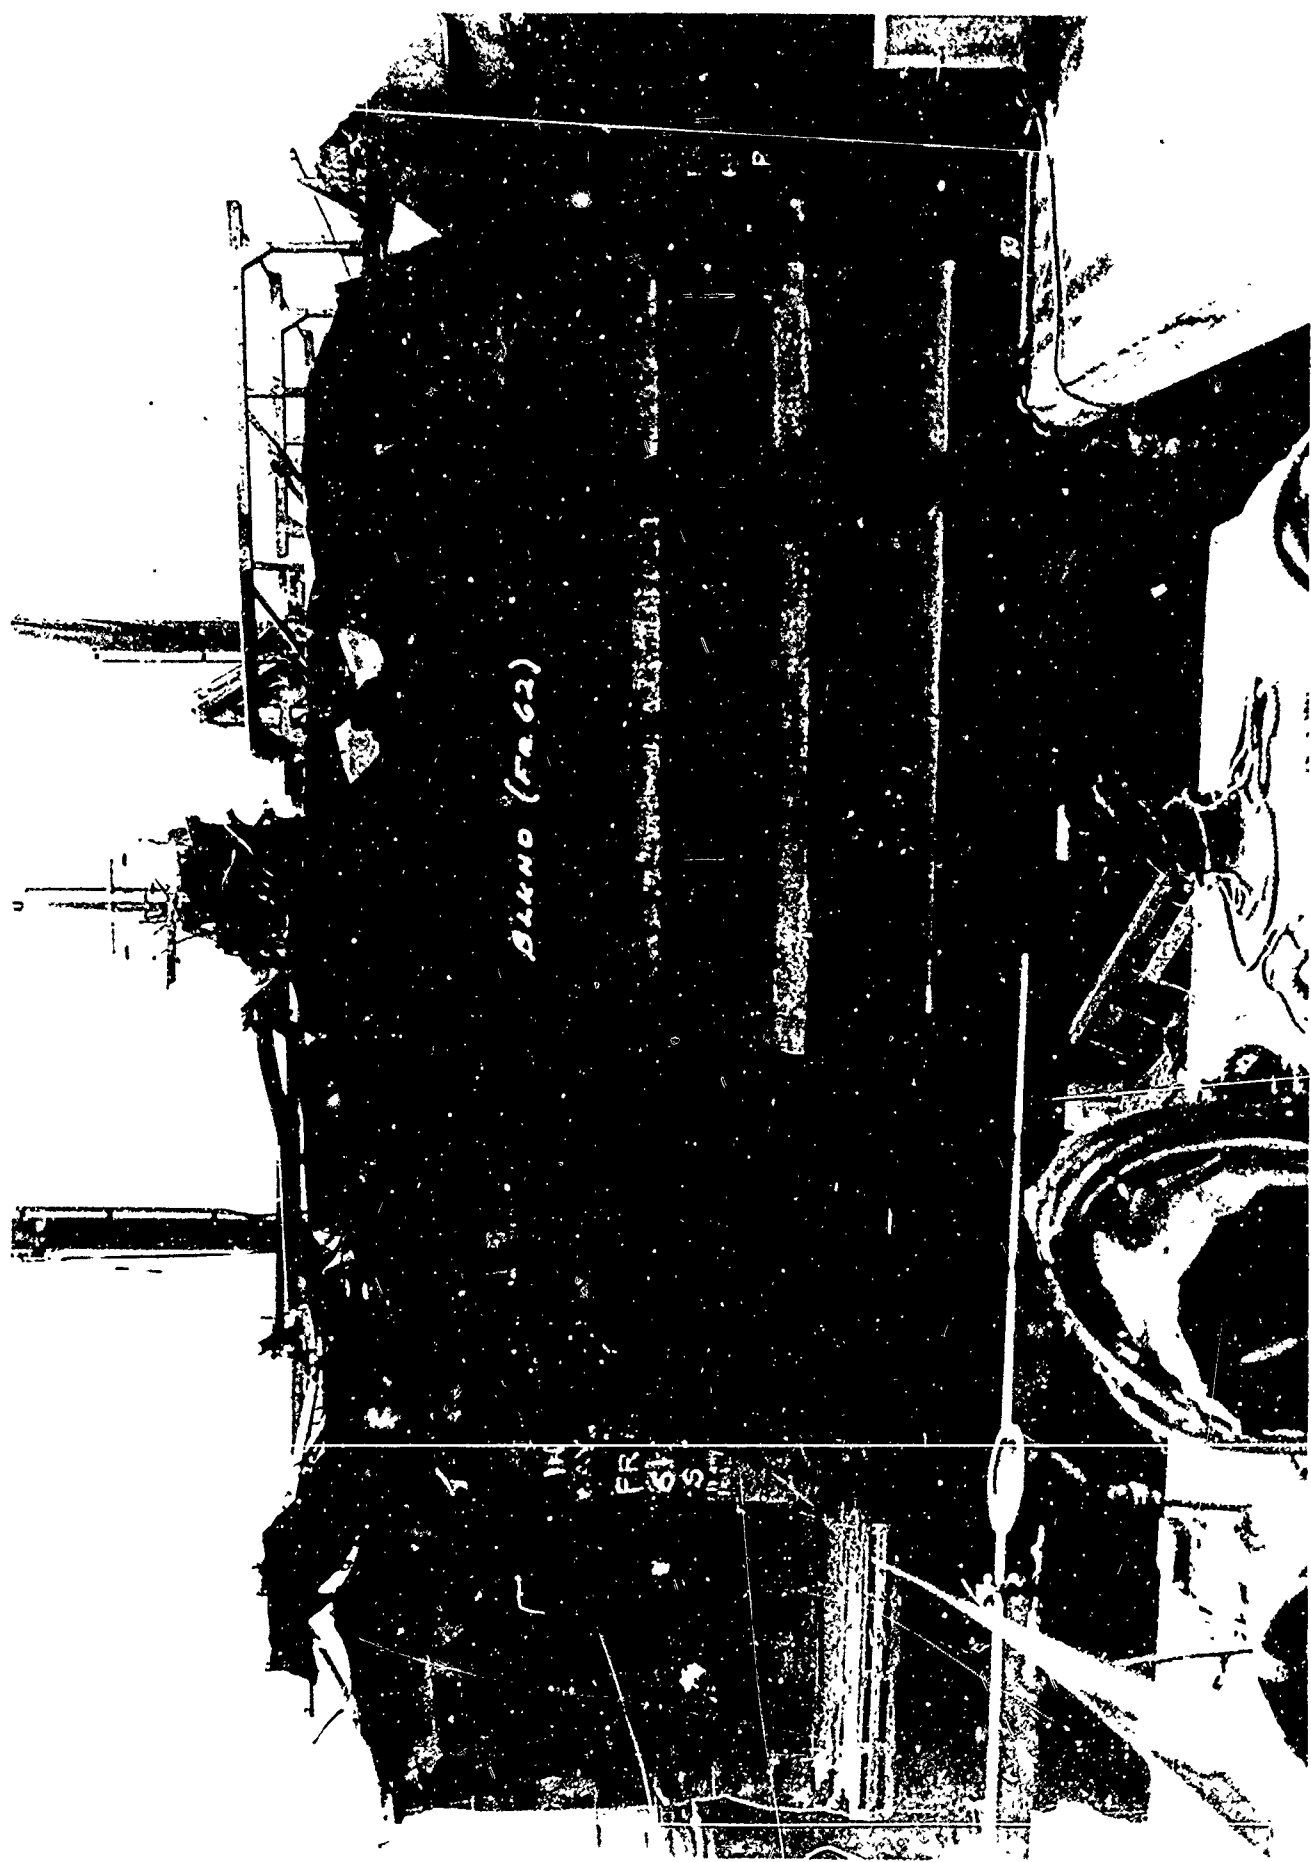
Figure 23.—Stern portion of S. S. Donbass III.

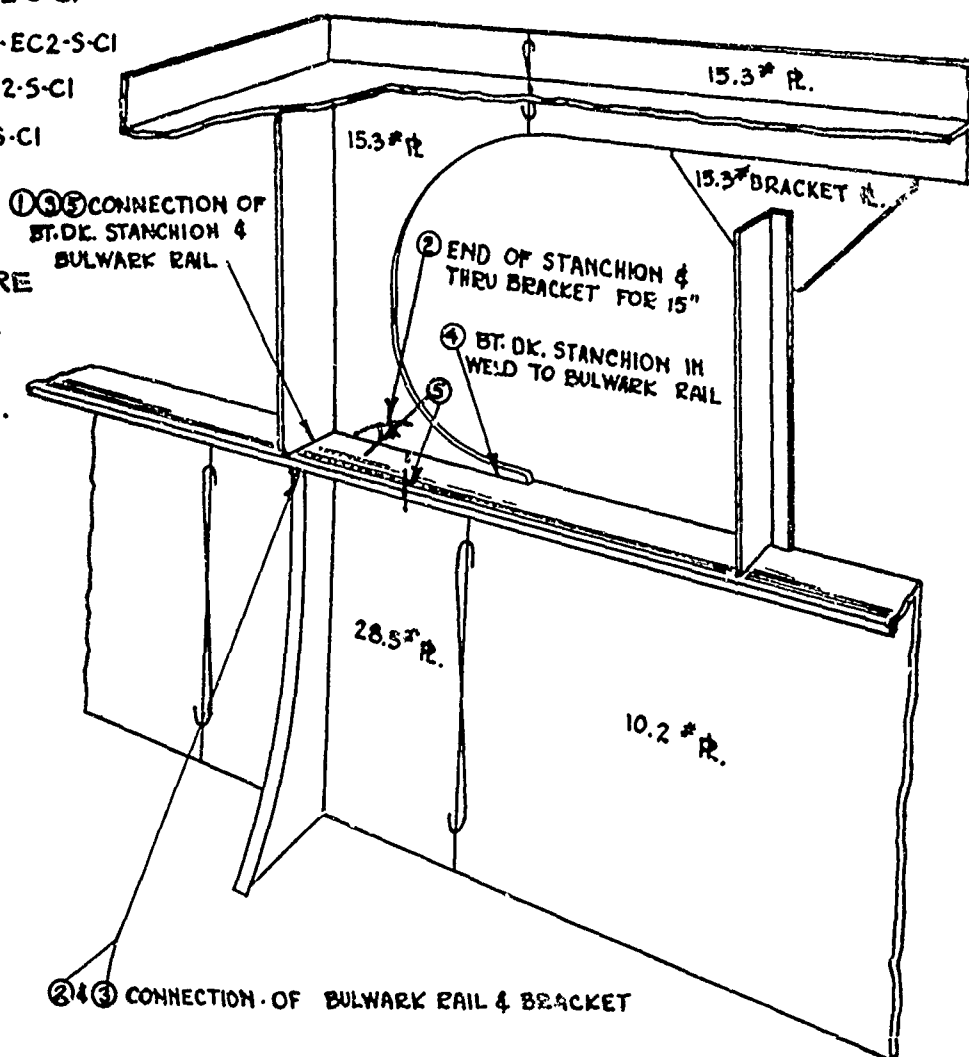
Figure 34.

UP TO 1, AUG, 1945
290 FRACTURES WERE
REPORTED TO HAVE
OCCURRED AT THE
BOAT DK. STANCHION.

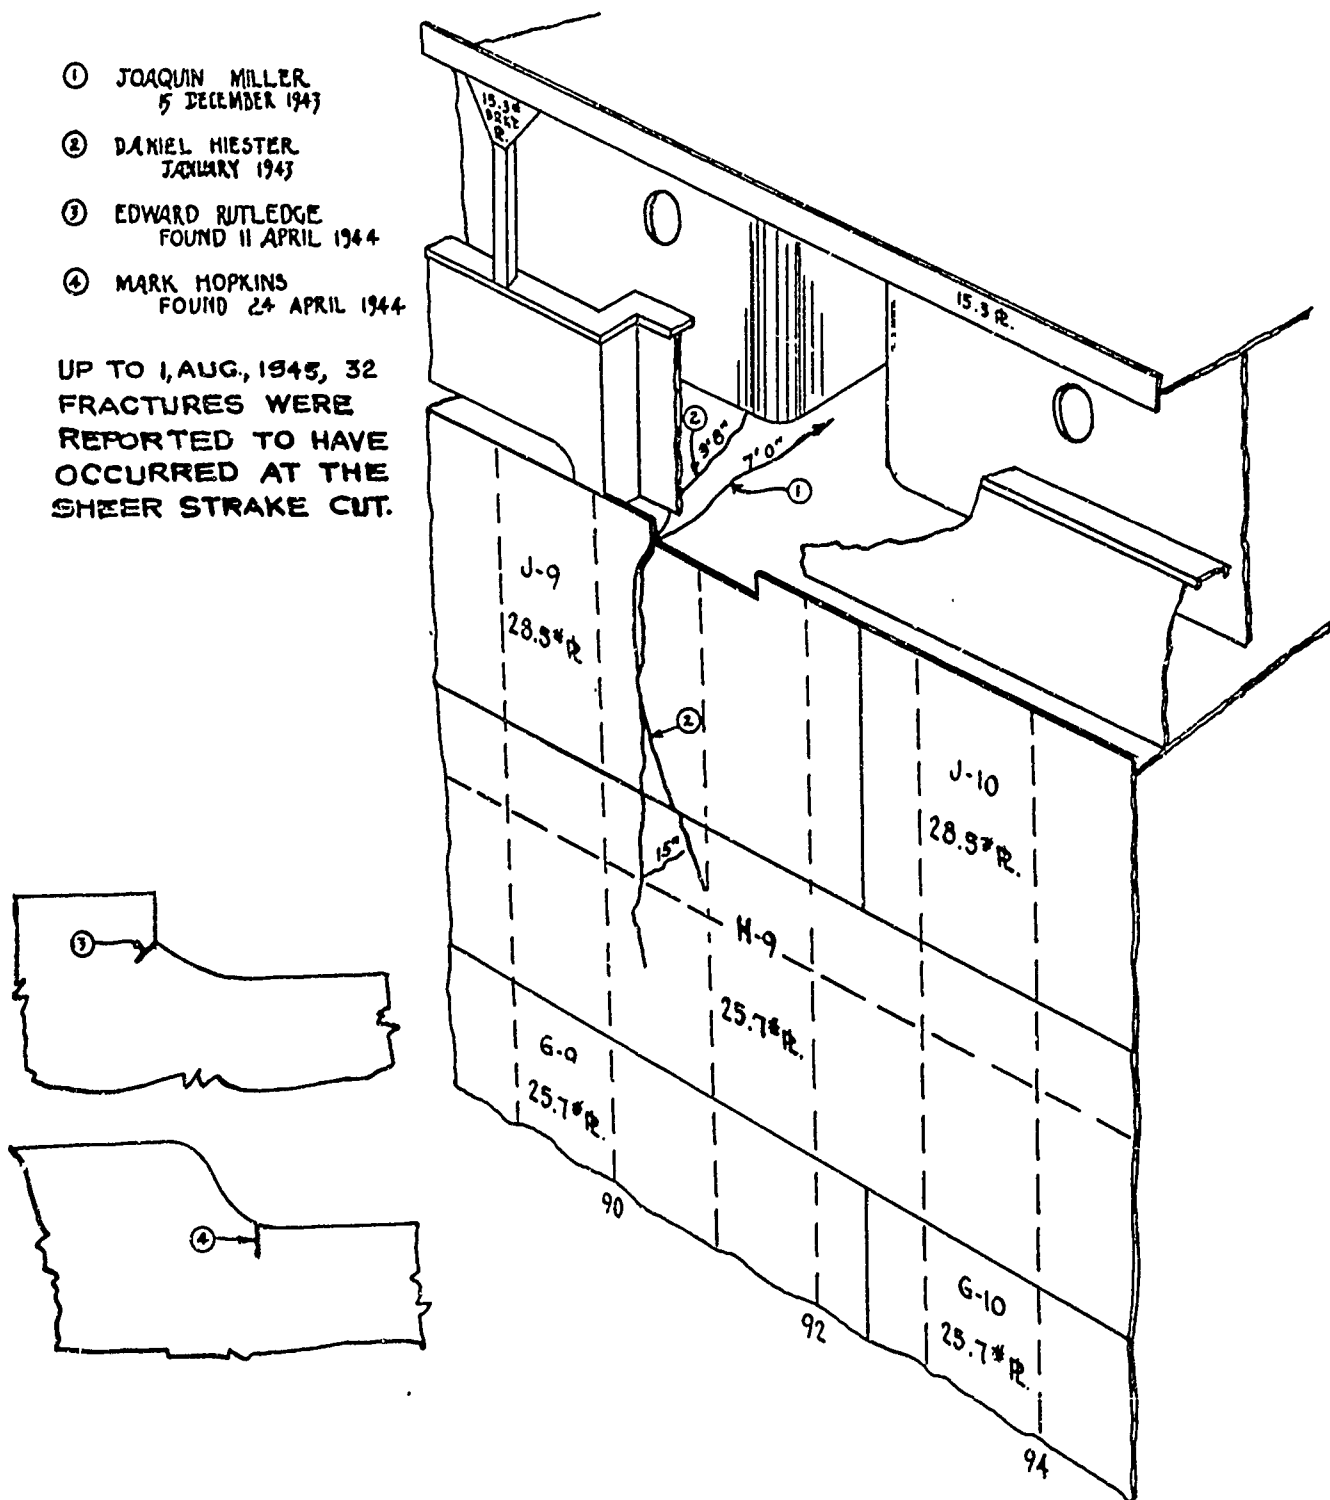
Figure 35.

UP TO 1, AUG., 1945, 32
FRACTURES WERE
REPORTED TO HAVE
OCCURRED AT THE
SHEER STRAKE CUT.

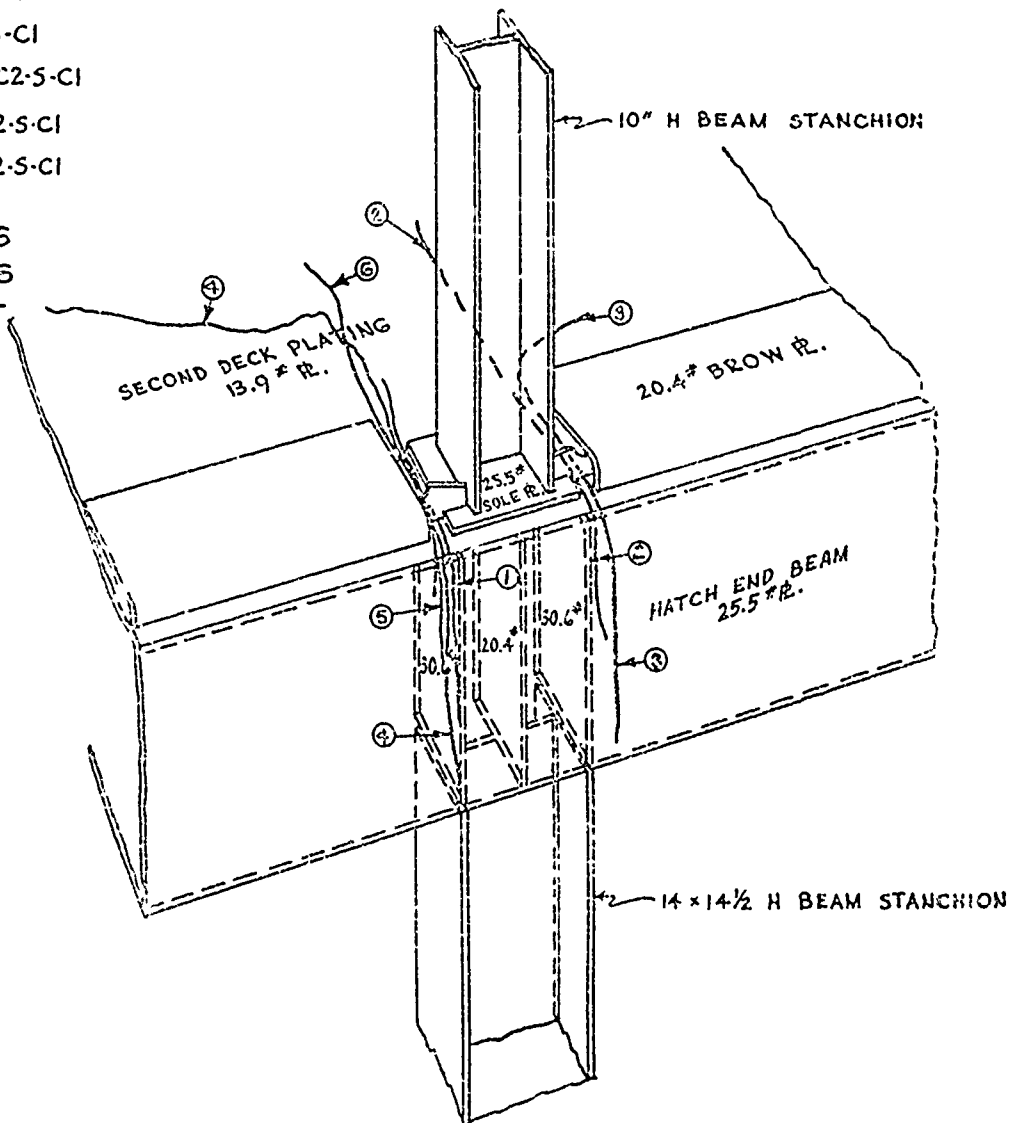
Figure 36.

UP TO 1, AUG, 1945, 36
FRACTURES OF THIS
TYPE HAD BEEN RE-
PORTED, INCLUDING
19 IN No. 2 HATCH
